Nordic Joist Repair Detail for Web Holes Close to Bearing

This technical note provides a repair detail for non-conforming web holes close to bearings in Nordic I-joists.

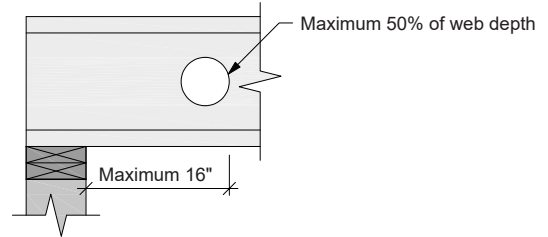
1. The I-joist supports uniform loads only.
2. The I-joist top and bottom flanges are not damaged.
3. The web hole diameter does not exceed 50% of the I-joist web depth.
4. The web hole is contained within 16 inches from the inside face of the support.

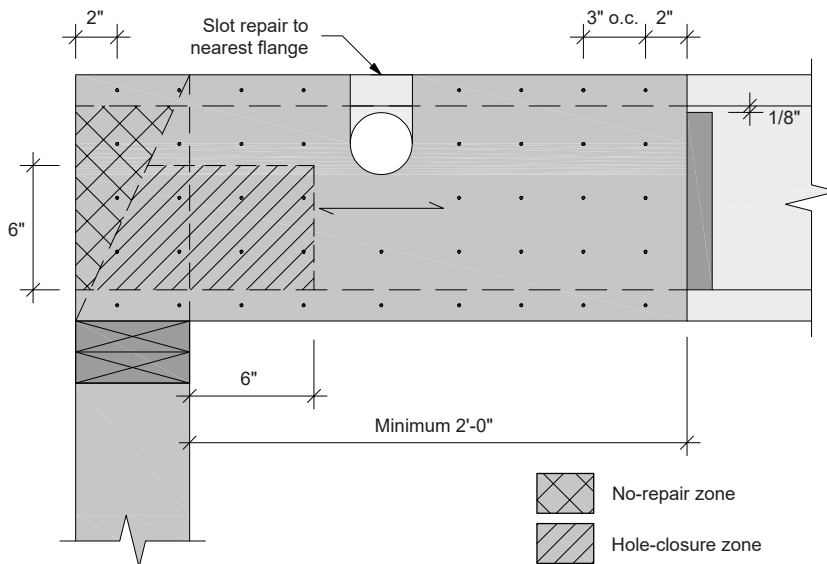
- Conditions:
 - No-repair zone: web holes contained within the no-repair zone illustrated below can be ignored.
 - Hole-closure zone: web holes intersecting the hole-closure zone illustrated below must be relocated outside the repair area.

- Other: web holes located elsewhere in the repair area can remain in place with the condition that the reinforcement is cut tight around them.
- Reinforcement:

Elevation view of a repaired I-joist

- Reinforcement shall extend a minimum of 2 feet from the inside face of the support and be installed on one side of the joist. Install with face grain horizontal, matching the joist depth.

- Use a wood structural panel with a minimum thickness of 23/32 inch (for OSB, panel mark 48/24).
- Backer block:
 - Install leaving a 1/8-inch gap between the top of the backer block and the bottom of the top flange.

- Use a wood structural panel or solid sawn lumber S-P-F No. 2 or better.
- Fasteners:
 - For 2x3 flanges, use 5 horizontal rows of 3-inch common nails at 3 inches o.c. (clinched when possible).

- For 2x4 flanges, use 5 horizontal rows of 3-1/2-inch common nails at 3 inches o.c. (clinched when possible).
 - One horizontal row of nails shall be centred on each flange; evenly space the remaining rows.

- Construction adhesive must be applied to all surfaces in contact.

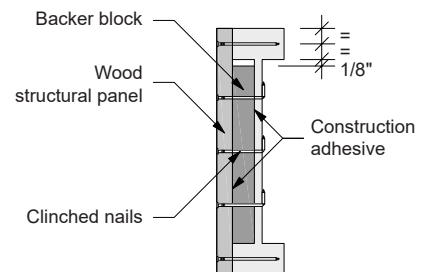
Section view of a repaired I-joist
