## Damaged Flanges in Nordic Joist

This technical note provides guidance on evaluating and repairing damaged flanges in Nordic I-joists.

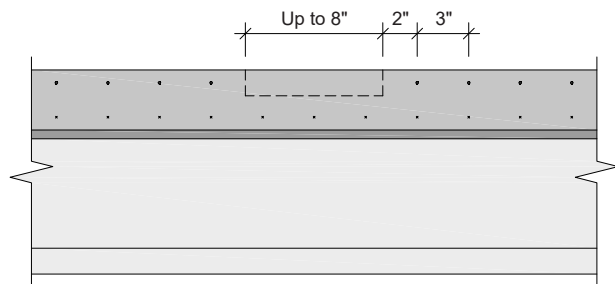
Elevation view of a repair to a damaged flange

- Reinforcement:
  - Reinforcement shall be applied to one or both sides of the affected flange, centred on the damaged area.
  - Web filler: wood structural panel or 2x member (where possible) on one side only.
  - Scab: 2x4 S-P-F No. 2 or better.
- Fasteners:
  - Minimum 2-inch end distance parallel to grain.
  - One row of nails centred on the damaged flange (through scab), and another placed at 1 inch from flange inner edge (through web and filler).
  - Use 2-1/2-inch common nails (2x3 flanges) or 3-inch common nails (2x4 flanges) at 3 inches o.c.
- Construction adhesive must be applied to all surfaces in contact.

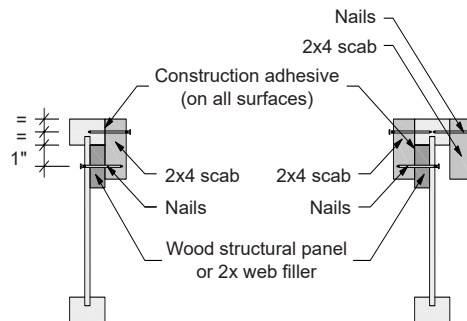
Section view of a repair to a damaged flange - One or two scabs
