Damaged Flanges in Nordic Joist

This technical note provides guidance on evaluating and repairing damaged flanges in Nordic I-joists.

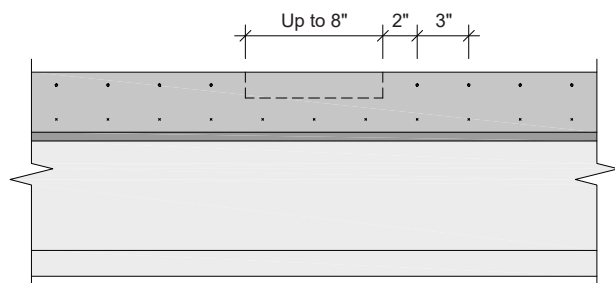
Elevation view of a repair to a damaged flange

- Reinforcement:
 - Reinforcement shall be applied to one or both sides of the affected flange, centered on the damaged area.
 - Web filler: wood structural panel or 2x member (where possible) on one side only.
 - Scab: 2x4 S-P-F No. 2 or better.
- Fasteners:
 - Minimum 2-inch end distance parallel to grain.
 - One row of nails centered on the damaged flange (through scab), and another placed at 1 inch from flange inner edge (through web and filler).
 - Use 8d common nails (2x3 flanges) or 10d common nails (2x4 flanges) at 3 inches o.c.
- Construction adhesive must be applied to all surfaces in contact.

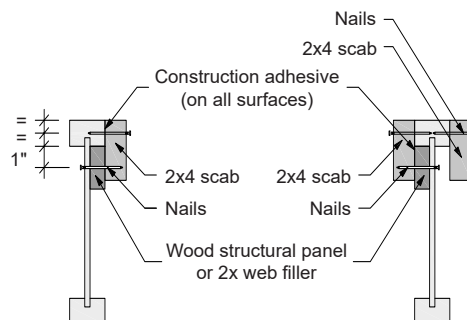
Section view of a repair to a damaged flange - One or two scabs
