# Mass Timber Connections Fire-Resistance Testing

For Nordic Structures

December 16, 2022

CHM FIRE CONSULTANTS LTD.  
858 Bank Street, Suite 103, Ottawa, ON, K1S 3W3

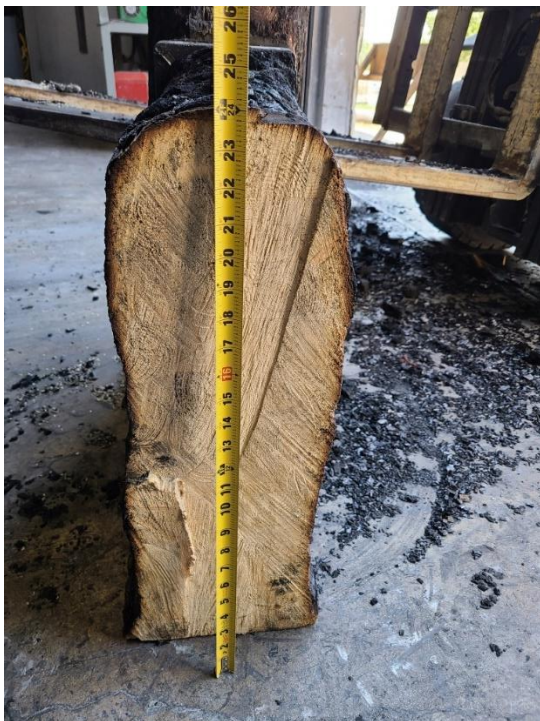
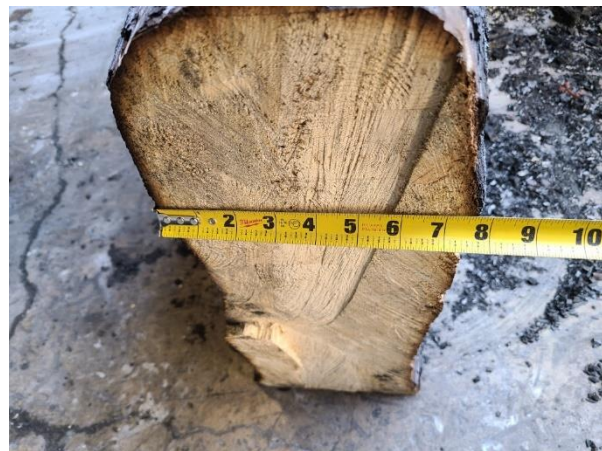
**Figure 13:** Beam remaining cross-section post-test

The beam was exposed to 3-sided fire exposure. The initial cross-section of the beam was 346 mm wide x 699 mm deep. After the fire exposure, the remaining cross-section (after removing char) was approximately 190 mm x 590 mm. As such, the average charring rates are:

- Width:  $(346-190)/(2 \times 120) = 0.65 \text{ mm/min}$
- Depth  $(699 - 590)/120 = 0.91 \text{ mm/min}$

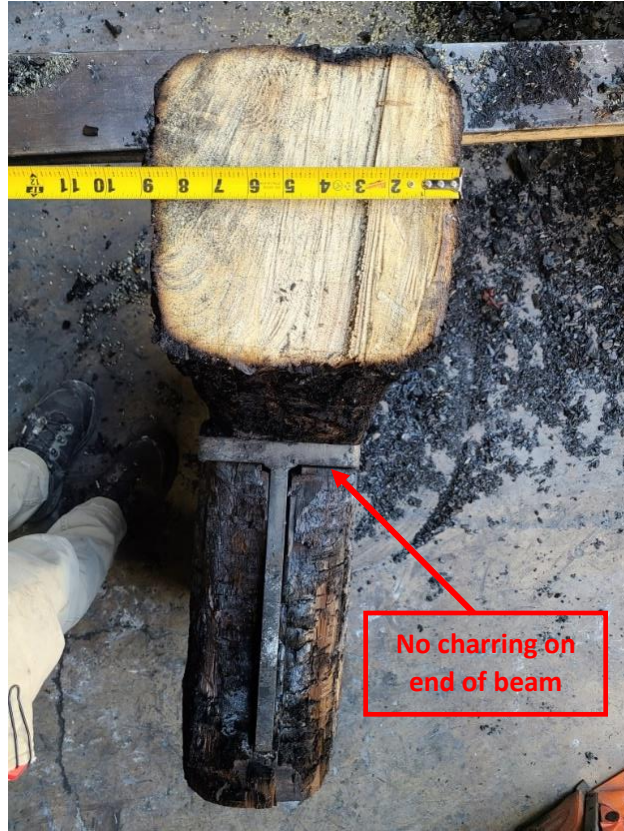
**Figure 14:** Column remaining cross-section post-test

As can be seen in Figure 14, which shows the bottom of the beam where it meets the steel plate, there was no charring between the end of the beam and the steel plate. The 5 mm gap which existed between the beam and column is no longer present as that wood was converted to char. However, it is clear from the remaining cross-section that no accelerated charring occurred on the end of the beam, or char contraction took place opening up the gap between the beam and column.

The column was exposed to 4-sided fire exposure. The initial cross-section of the column was 395 mm x 395 mm. After the fire exposure, the remaining cross-section (after removing char) was approximately 216 mm x 216 mm. As such, the charring rate was the same in both cross-sectional dimensions. The average charring rate is:

- $(395 - 216)/(2 \times 120) = 0.75 \text{ mm/min}$

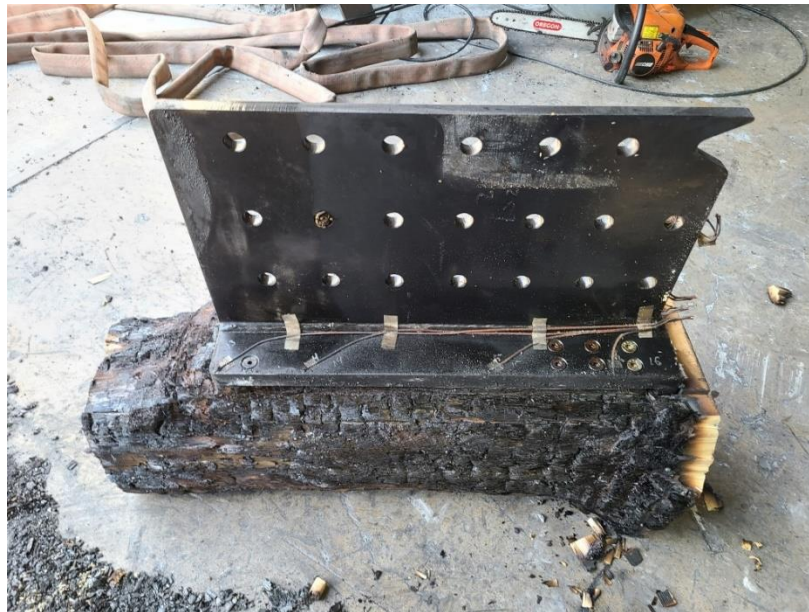
**Figure 15:** Knife plate-column connection post-test

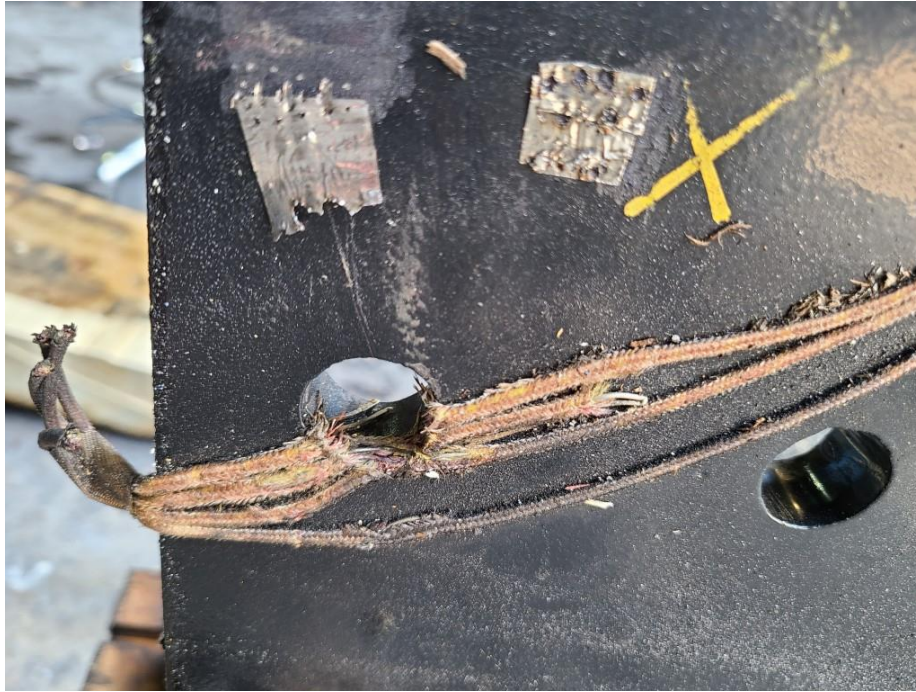
**Figure 16:** Photo showing damage to TC wires due to tight construction tolerances during fabrication (from top to bottom, TC1, TC4, TC2, TC3).

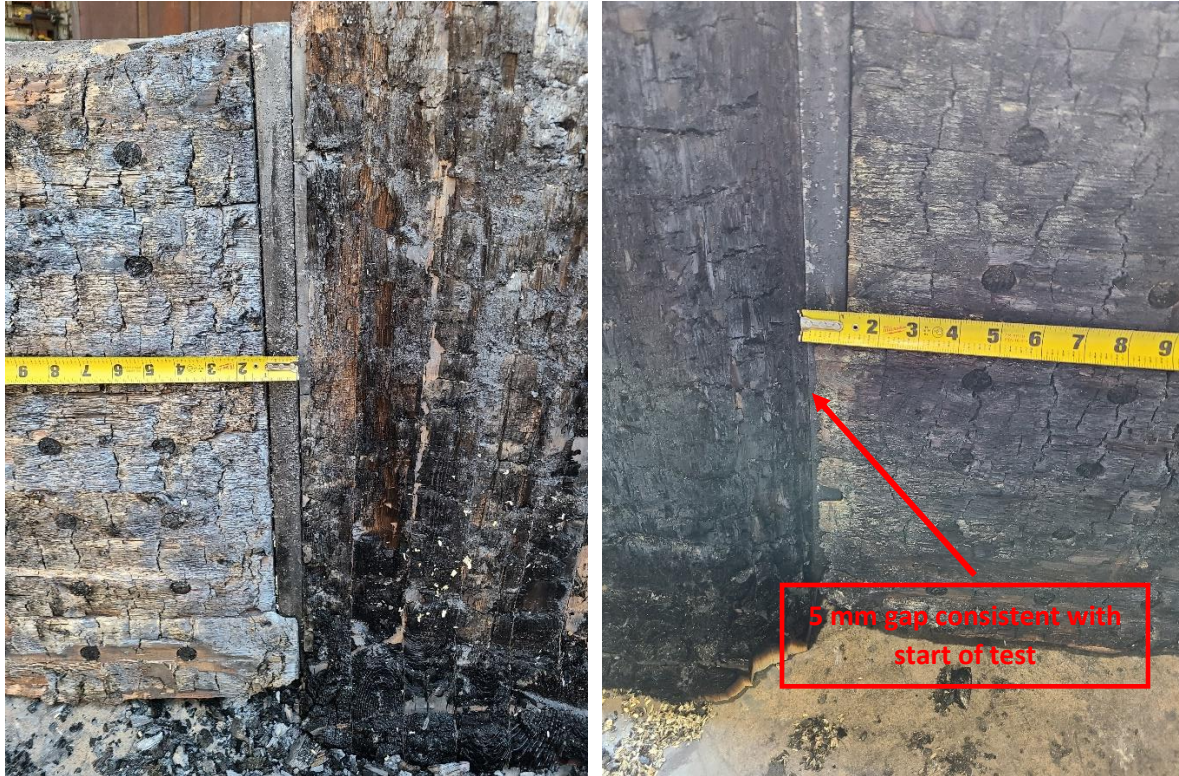
**Figure 17:** Photo showing remaining wood at end of beam on each side. The areas where wood remains between beam and column is consistent with the end gap of 5 mm between beam and column.

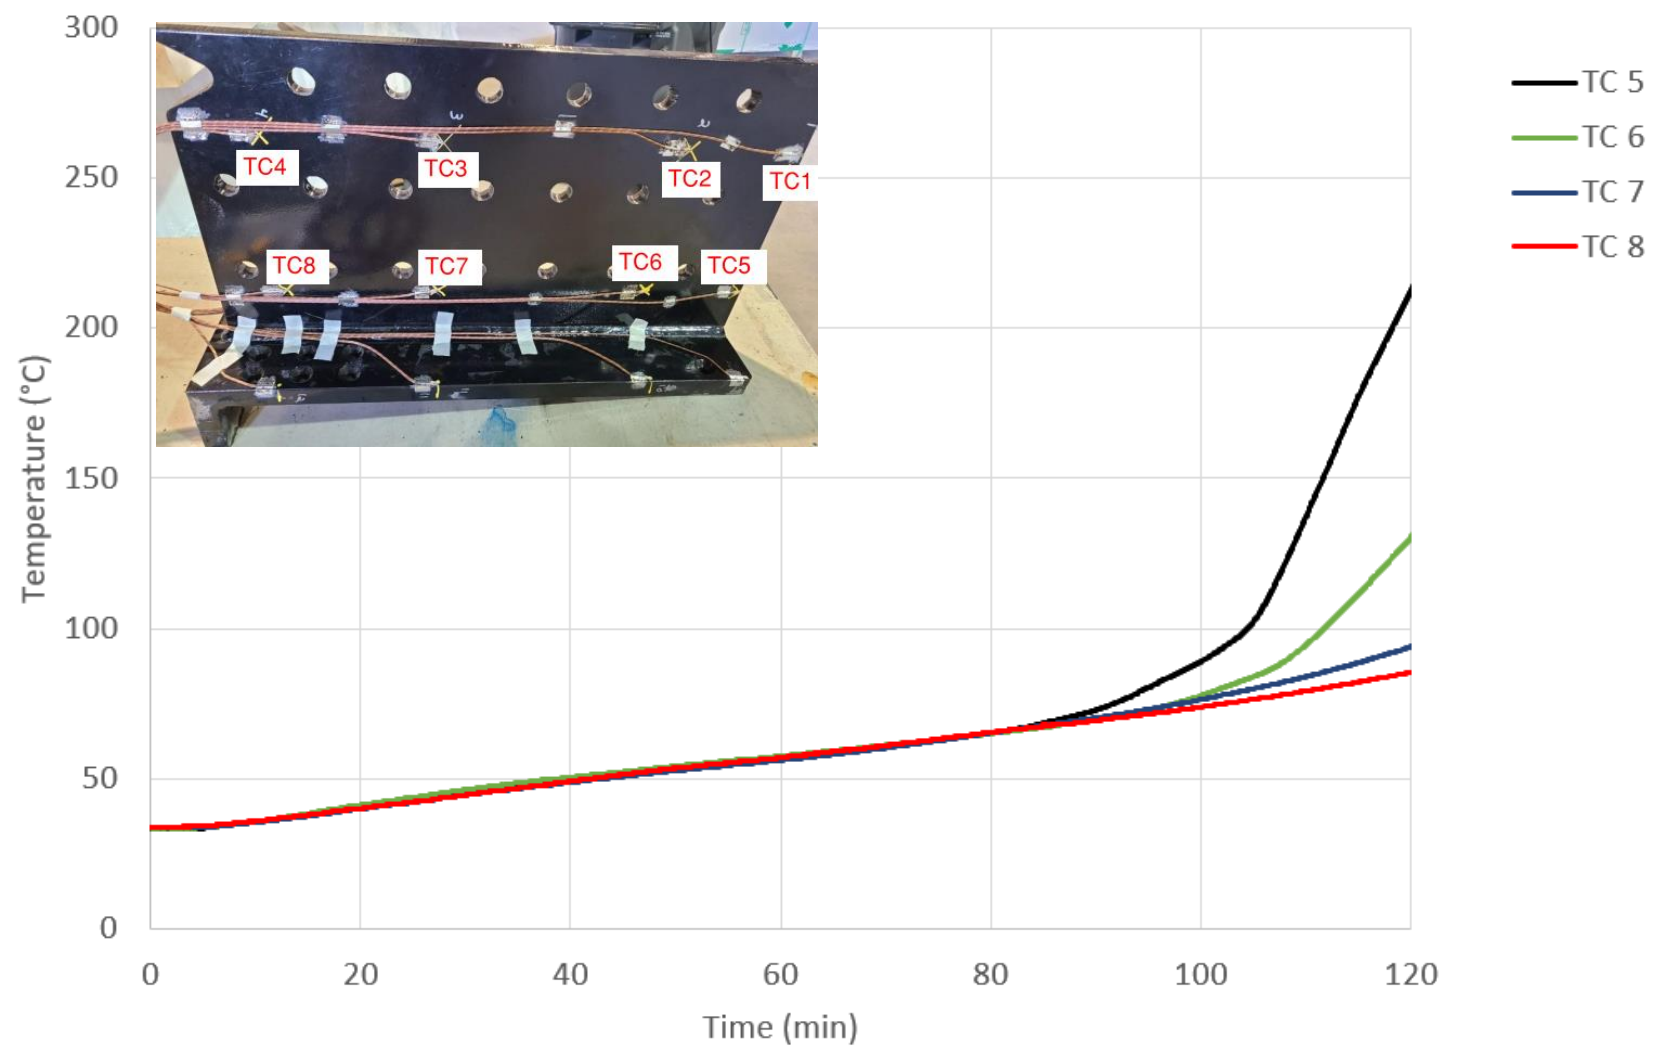
Figure 18 below is a graph of the temperatures of the 8 thermocouples on the knife plate in Test 1 (TC 1-8). The peak temperature reached at the bottom of the knife plate was at TC5, which reached 218°C at 120 minutes. While TC5 reached a peak temperature of 218°C, TC6 directly above reached a peak of 134°C which shows the relatively high temperature gradient in the steel knife plate. This is most likely a function of the relatively thick steel plate (19 mm).

**Figure 18:** Test 1 Steel Temperatures – Knife Plate (Note TCs 1-4 were damaged and therefore not included in the graph).

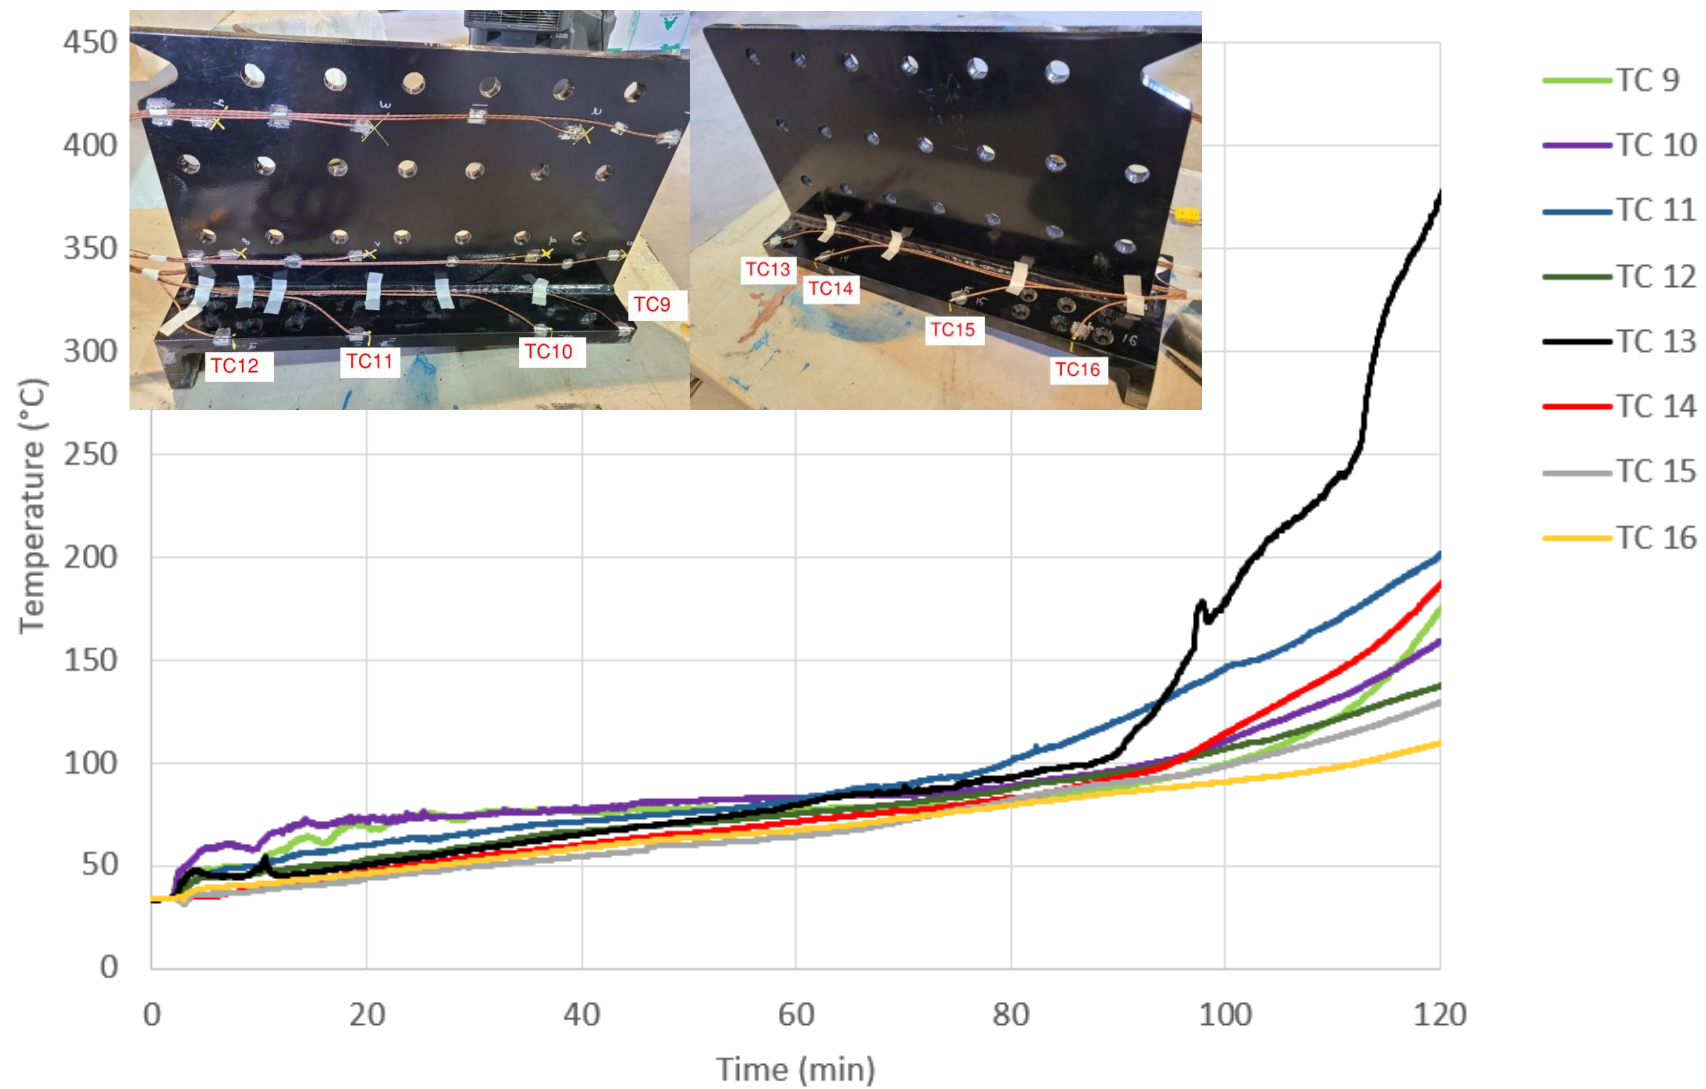
Figure 19 below is a graph of the temperatures of the 8 thermocouples on the back plate in Test 1 (TC 9-16). The temperatures for the most part stayed below 200°C for the duration of the test. The one exception was TC 13 which was on the bottom corner of the back plate attached to the column. It is not surprising the temperature was highest at this location where the peak reached approx. 375°C given the proximity to fire temperatures in two directions (bottom and side). Again, given the relatively thick steel (25 mm), the temperature at TC 14 just above TC 13 didn't reach 200°C.

**Figure 19: Test 1 Steel Temperatures – Back plate attached to column**

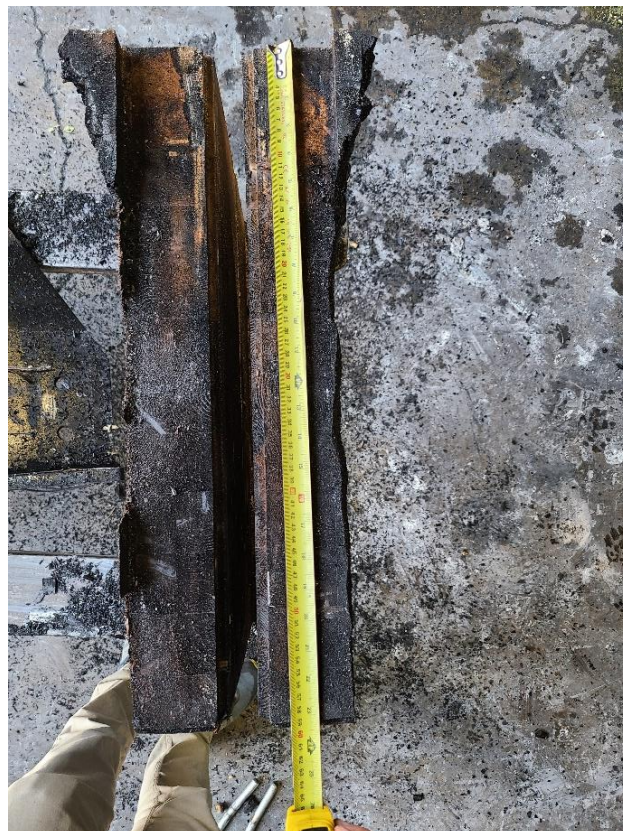
**Figure 29:** Beam remaining cross-section post-test

The beam was exposed to 3-sided fire exposure. The initial cross-section of the beam was 346 mm wide x 699 mm deep. After the fire exposure, the remaining cross-section (after removing char) was approximately 180 mm x 590 mm. As such, the average charring rates are:

- Width:  $(346-180)/(2 \times 120) = 0.69 \text{ mm/min}$
- Depth  $(699 - 590)/120 = 0.91 \text{ mm/min}$

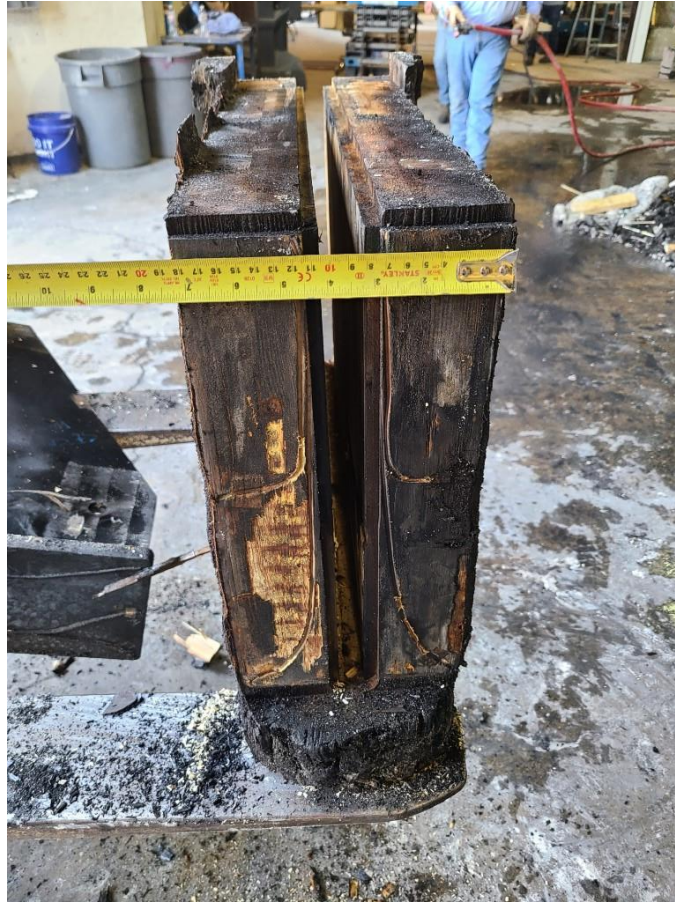
**Figure 30:** Bottom of beam post-test

As can be seen in Figure 30, which shows the bottom of the beam where it rested on the steel bearing plate, there was no charring of the wood between the beam and the bearing plate. Figure 29 shows the end of the beam which terminates at the steel plate attached to the column. Again, no significant charring took place on the end of the beam. The 3 mm gap which existed between the beam and column is no longer present as that wood was largely converted to char. However, it is clear from the remaining cross-section shown in Figure 32 below (circled portion) that no accelerated charring occurred on the end of the beam, or char contraction took place opening up the gap between the beam and column.

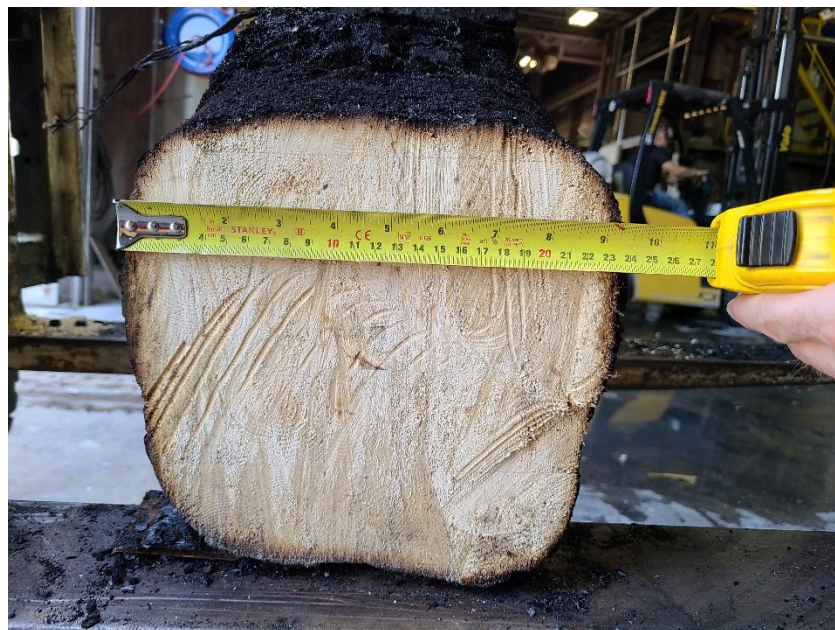
**Figure 31:** Column remaining cross-section post-test

The column was exposed to 4-sided fire exposure. The initial cross-section of the column was 395 mm x 395 mm. After the fire exposure, the remaining cross-section (after removing char) was approximately 220 mm x 220 mm. As such, the charring rate was the same in both cross-sectional dimensions. The average charring rate is:

- $(395 - 220)/(2 \times 120) = 0.73 \text{ mm/min}$

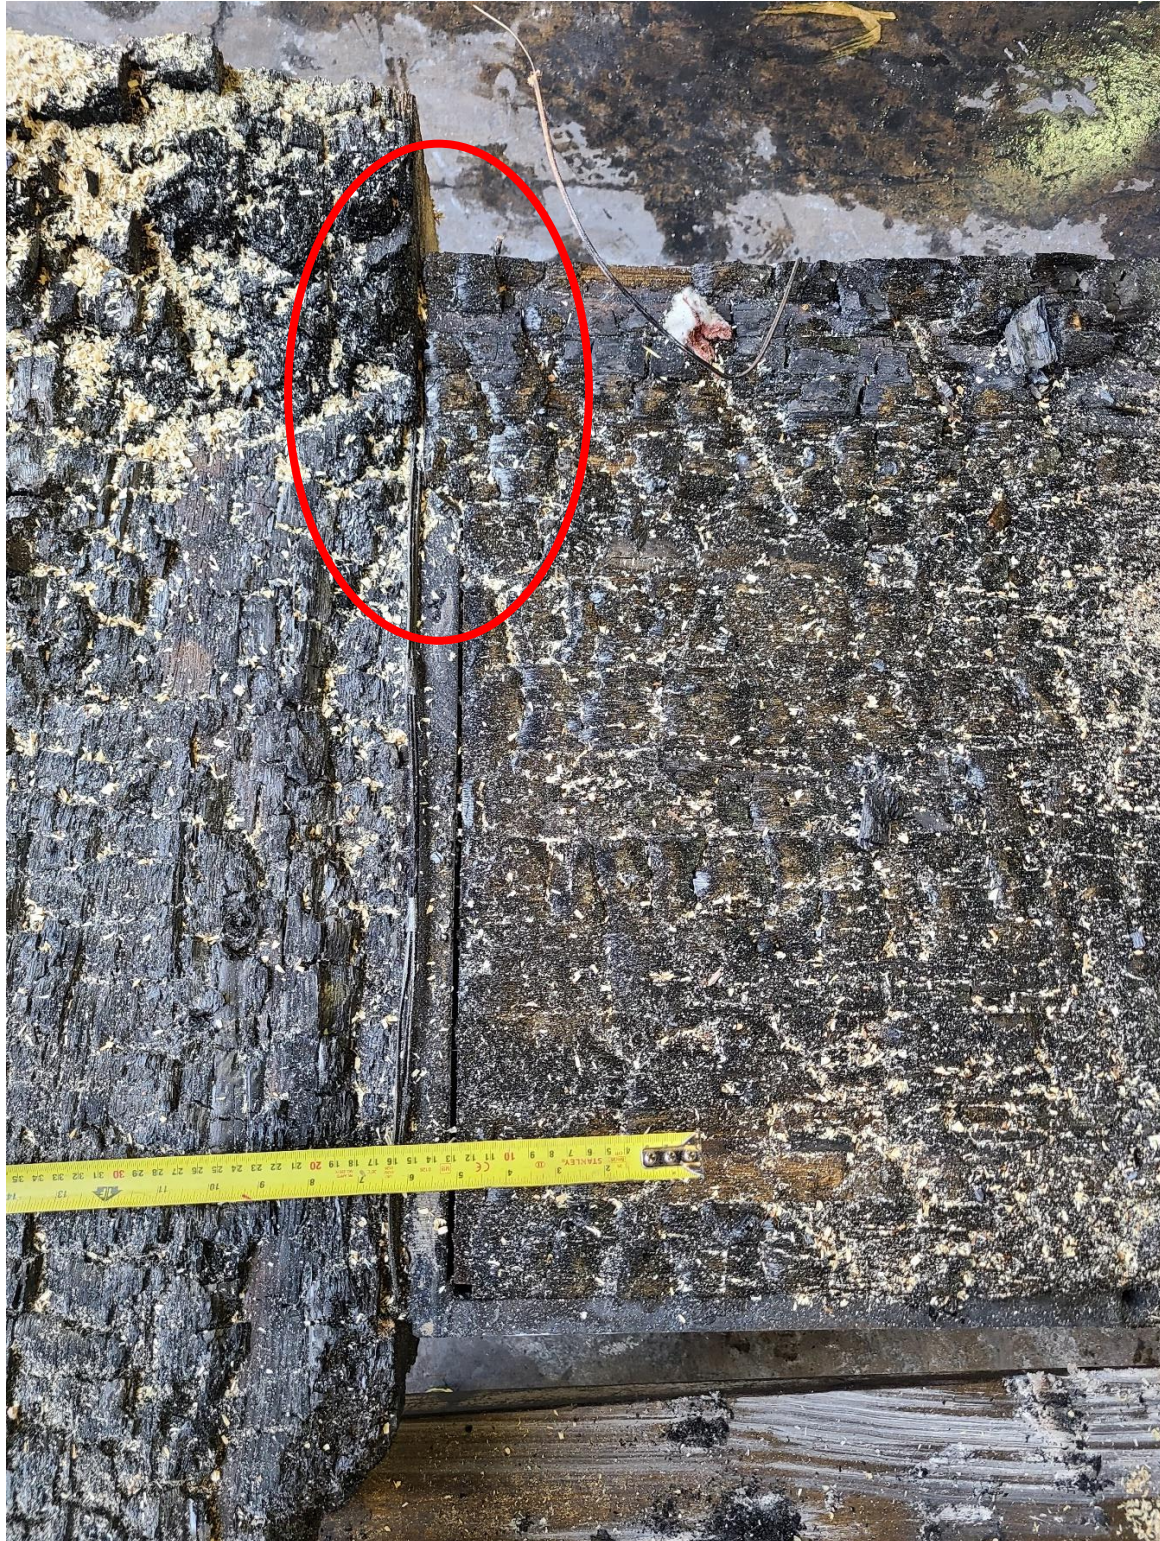
**Figure 32:** Remaining cross-section of beam with small amount of wood showing 3 mm gap did not expand significantly.

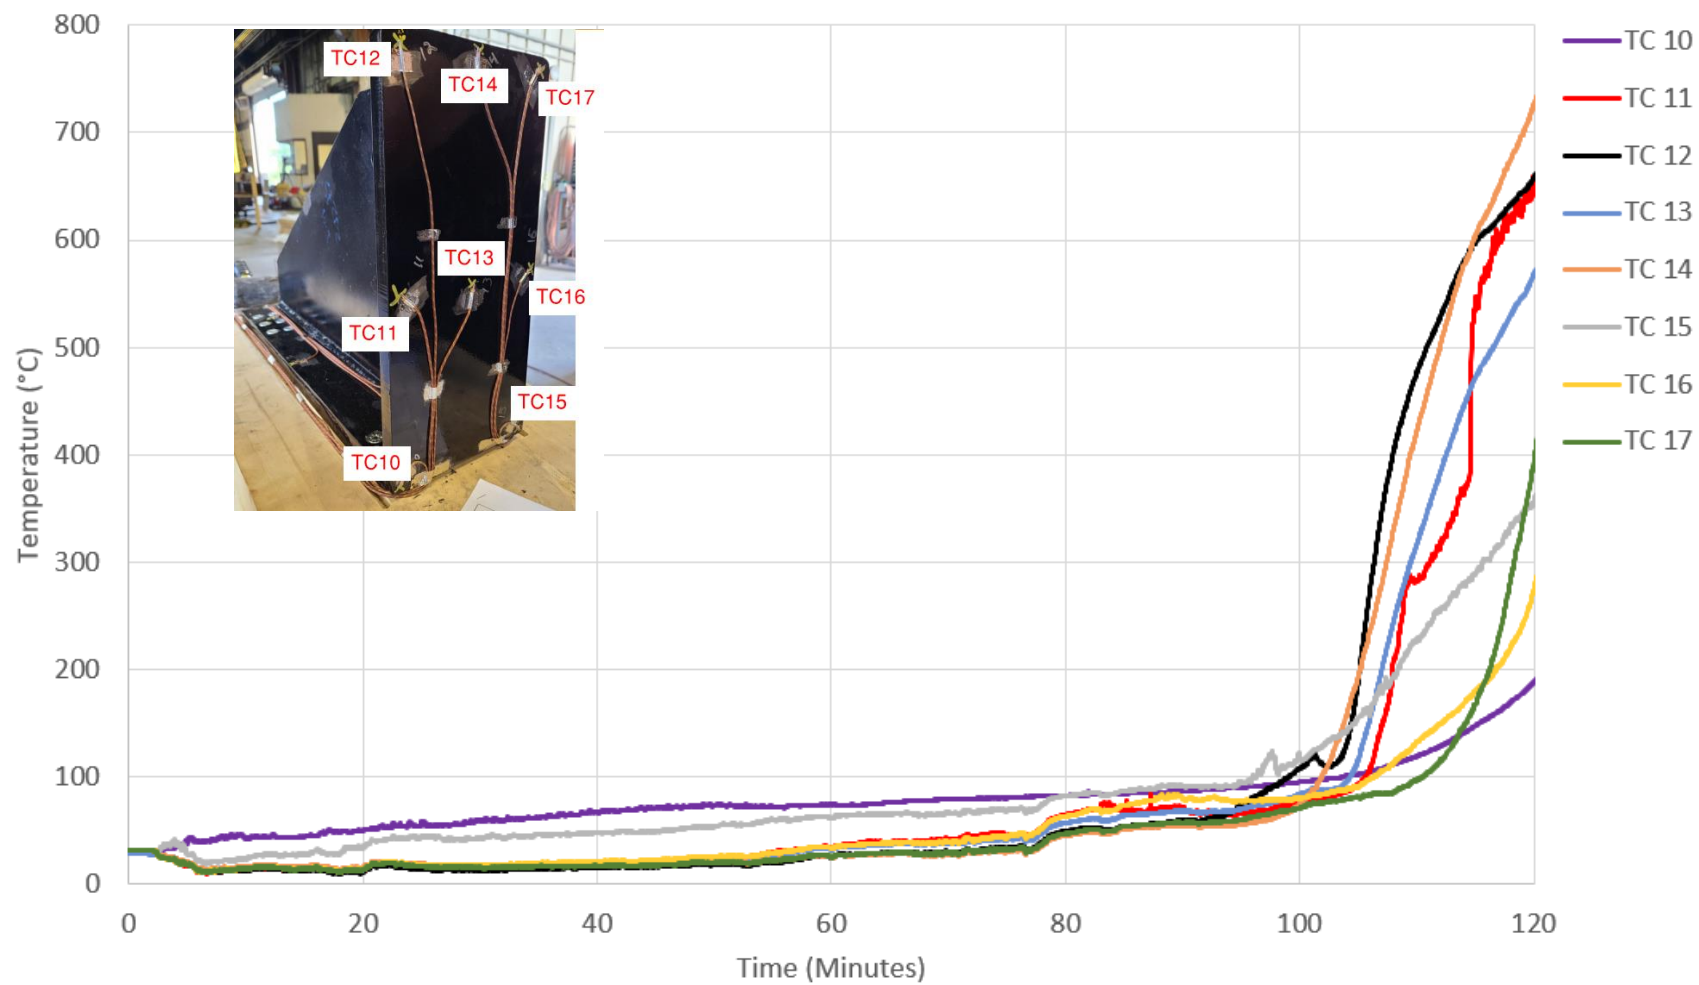
Figure 33 below is a graph of the temperatures of the thermocouples on the bottom of the steel bearing plate in Test 2. The peak temperature reached on the steel bearing plate was at TC14, which reached 726°C at 120 minutes. While this temperature is well above that of charring of wood (300°C), it is notable that the wood above the bearing plate did not char. Again, this is an indication of the temperature gradient in the relatively thick steel plates (19 mm).

Some of the temperatures in Figure 33 drop early in the test and take a long time to reach the temperature at the start of the test. The testing lab was unable to identify the reason for this drop, and therefore, the temperatures measured should be considered along with all the other measurements to avoid drawing improper conclusions.

**Figure 33:** Test 2 Steel Temperatures – Underside of Bearing Plate

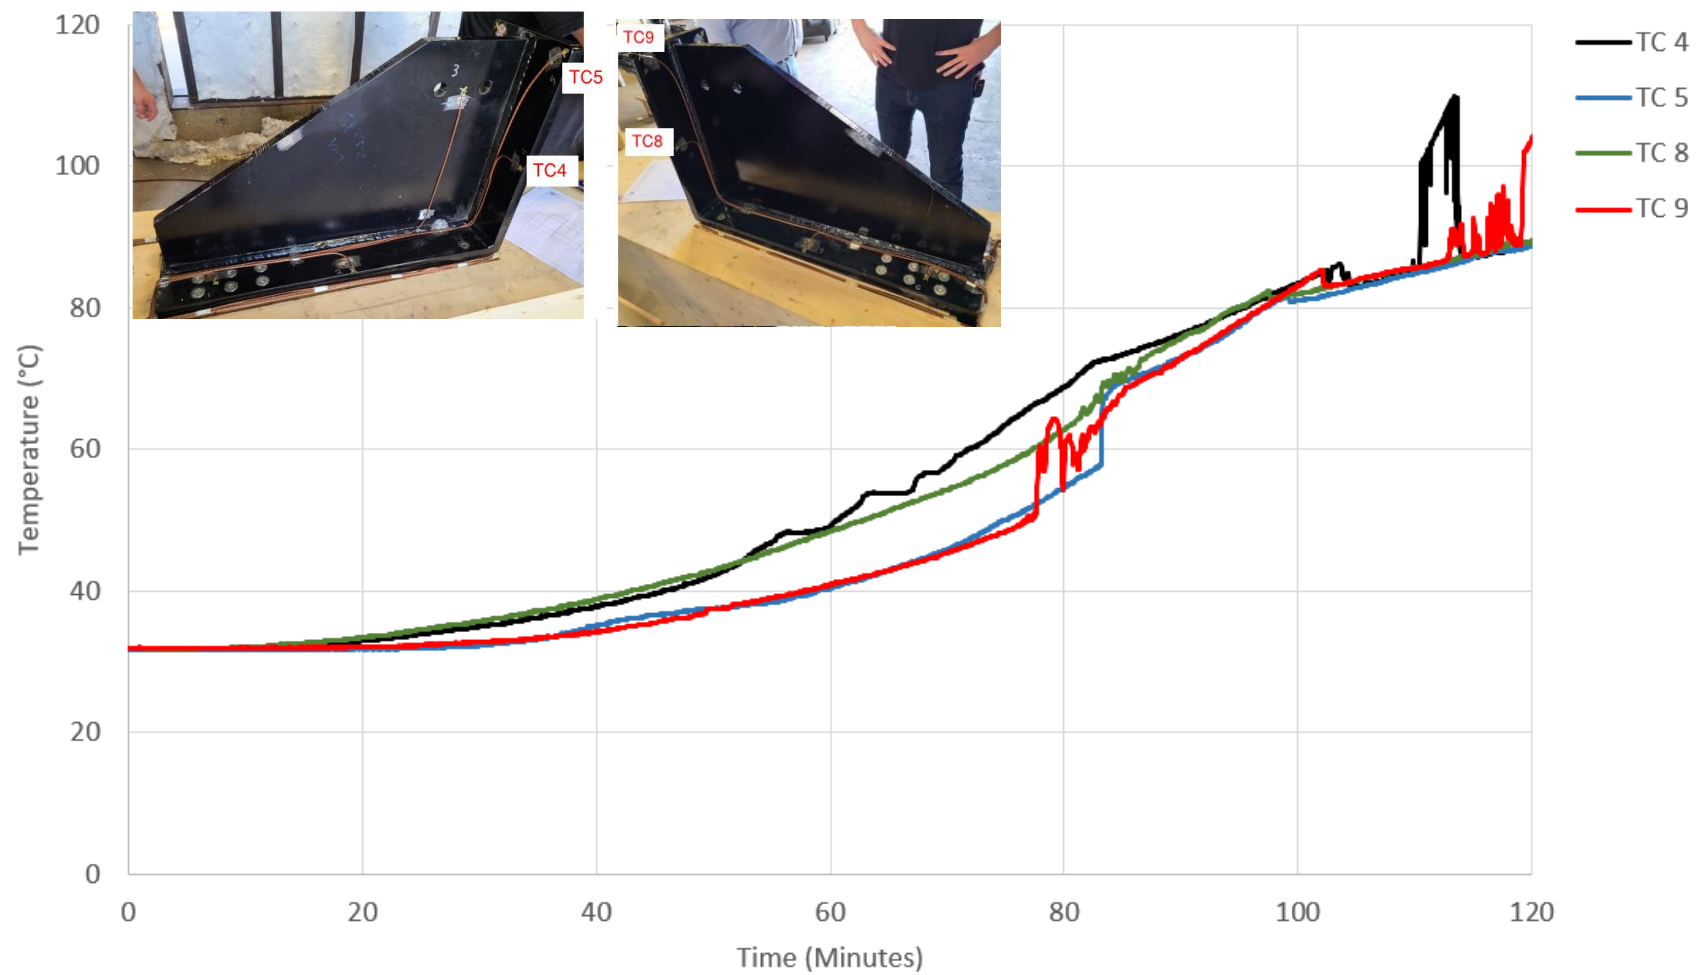
Figure 34 below is a graph of the temperatures of the 4 thermocouples on the top of the bearing plate in Test 2. The temperatures for the most part stayed below 100°C for the duration of the test (with the exception of some fluctuations late in the test likely due to noise in the signal). The low temperatures are somewhat confirmed by the lack of charring of the wood on the bottom of the beam which rested on the bearing plate.

**Figure 34:** Test 2 Steel Temperatures – Top side of Bearing Plate

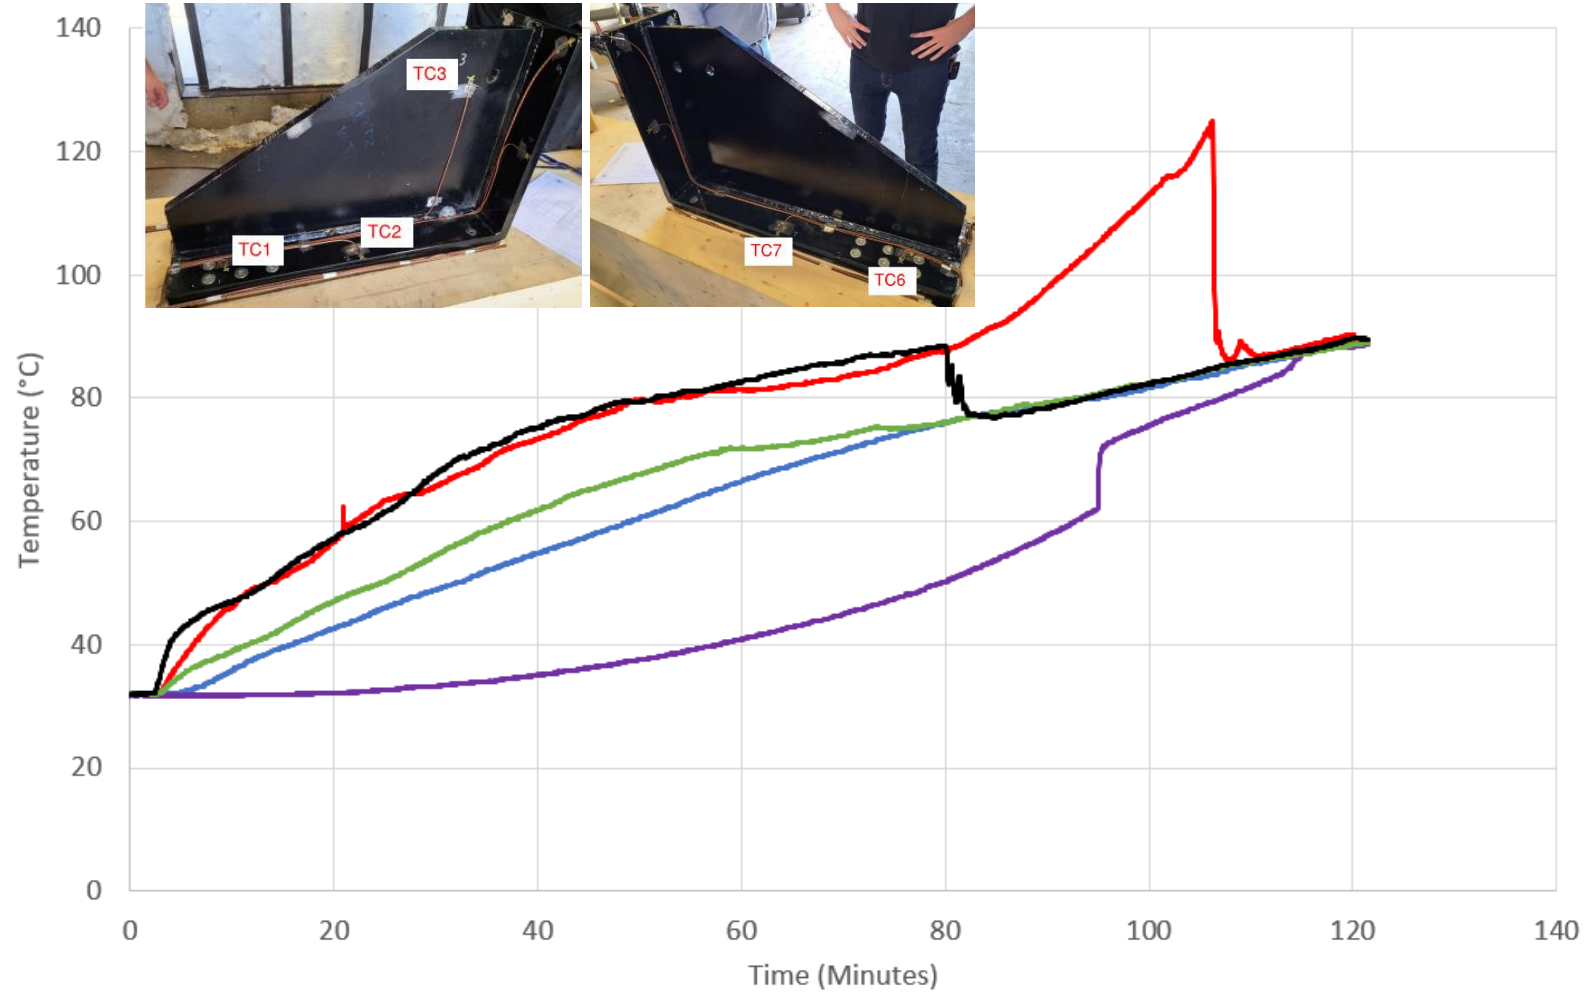
Figure 35 below is a graph of the temperatures of the thermocouples on the back plate connected to the column, and the knife plate in Test 2. For the most part the temperatures stayed below 100°C with the exception of an anomaly in the measurement which saw the temperature climb up above 120°C, only to drop quickly shortly after 100 minutes into the test. The 3 mm gap did not let any significant amount of heat into the joint.

**Figure 35:** Test 2 Steel Temperatures – Back plate and knife plate
