# Mass Timber Connections Fire-Resistance Testing

For Nordic Structures

December 16, 2022

CHM FIRE CONSULTANTS LTD.  
858 Bank Street, Suite 103, Ottawa, ON, K1S 3W3

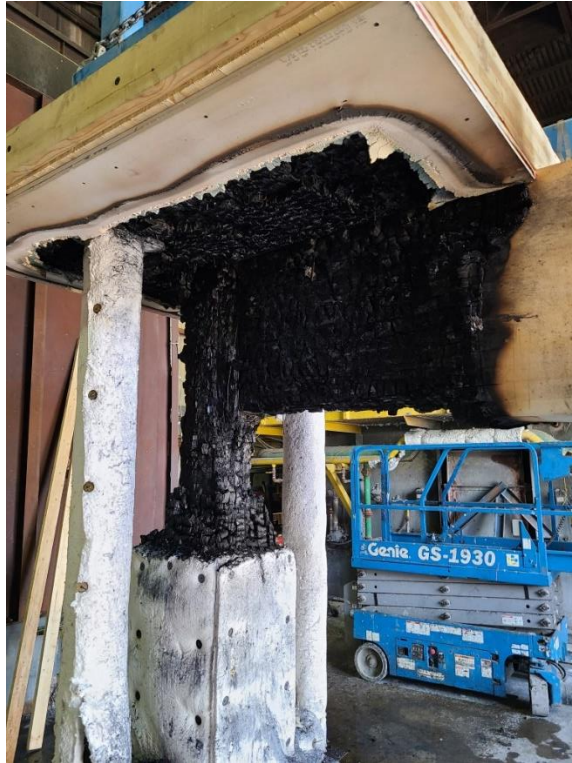
**Figure 12:** Test assembly post-test

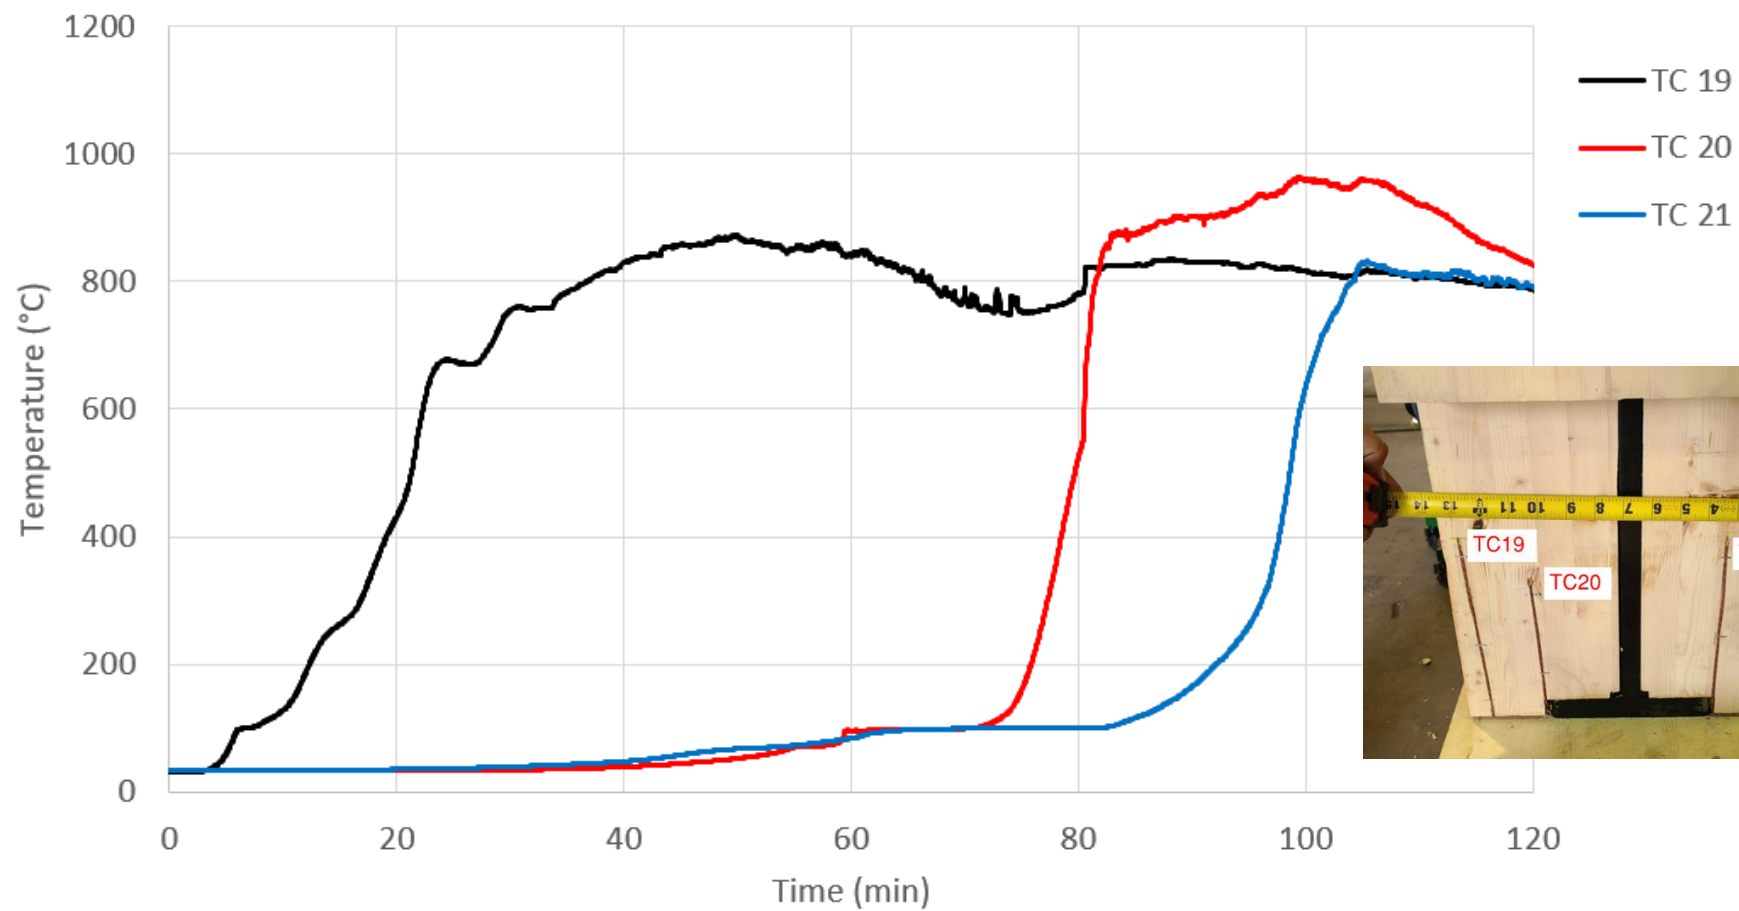
**Figure 20:** Thermocouple data – between beam and wood blocking – Test 1

Figure 20 below shows the thermocouple data between the beam and the wood blocking. Given the temperatures measured are somewhat below the furnace temperature ( $\sim 1027^{\circ}\text{C}$  at 2 hrs), it is likely the charred wood block remained in place providing some level of protection from the radiation in the furnace (dominate form of heat transfer given the high temperatures) long after it was fully charred.

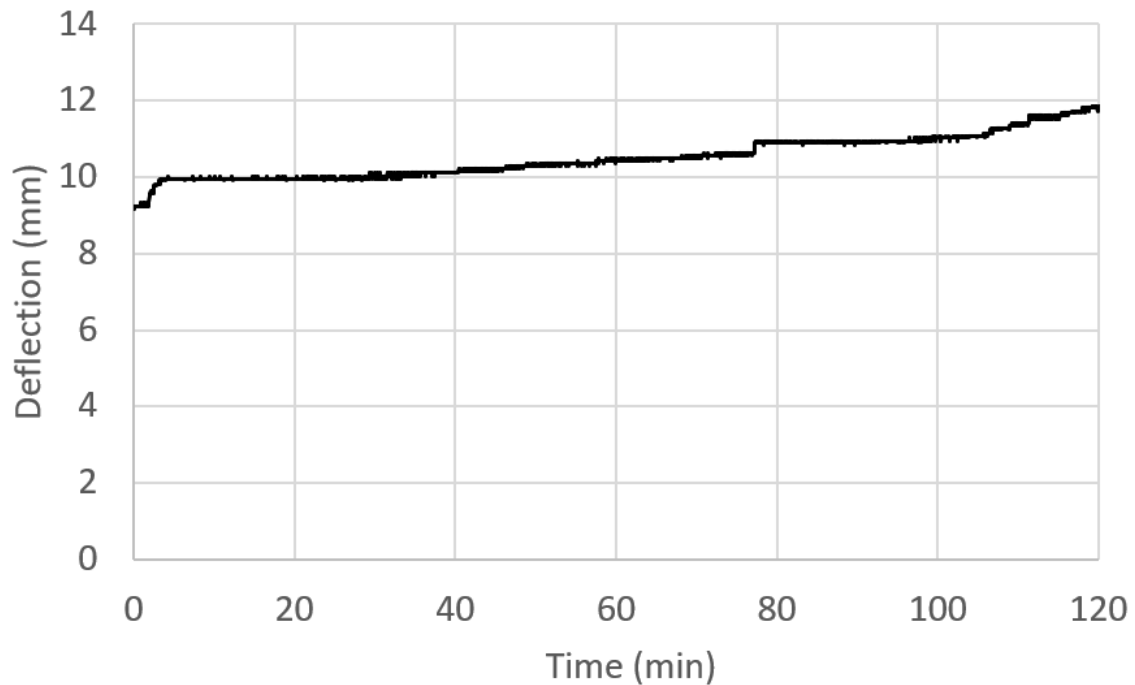
**Figure 21:** Deflection - Test 1

Figure 21 below shows the deflection throughout Test 1. The deflection when the load of 35.8 kips was applied was 9.2 mm. The maximum deflection measured after 2 hours was 11.8 (0.465") including the initial deflection. Therefore, deflection during the fire test was 2.6 mm which is only 28% of the initial deflection and is considered extremely little deflection to take place during a fire test.

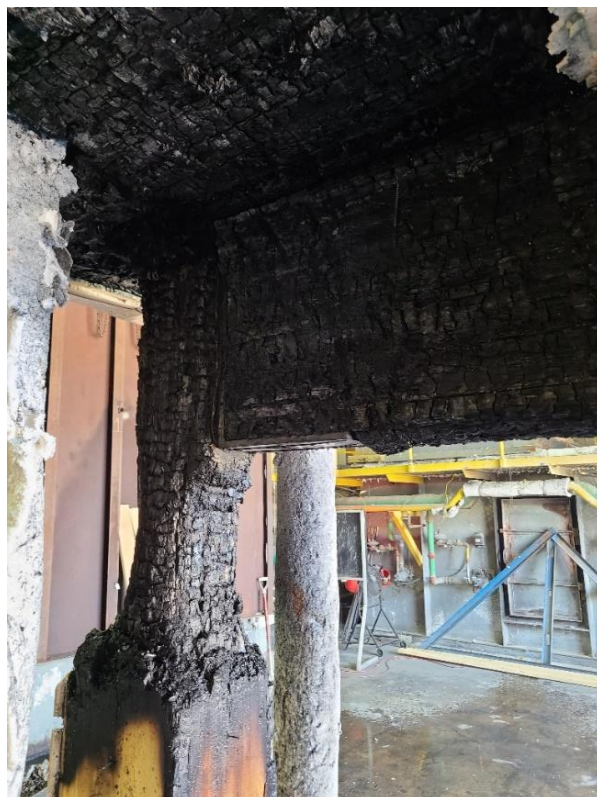
**Figure 27:** Test assembly post-test

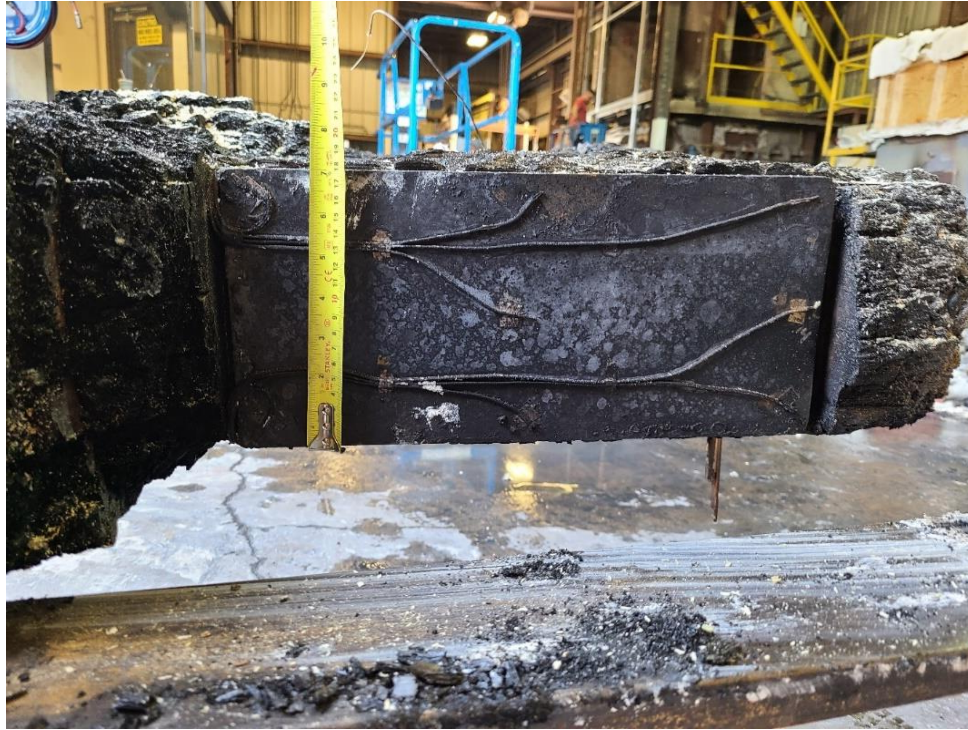
**Figure 28:** Bearing plate post-test

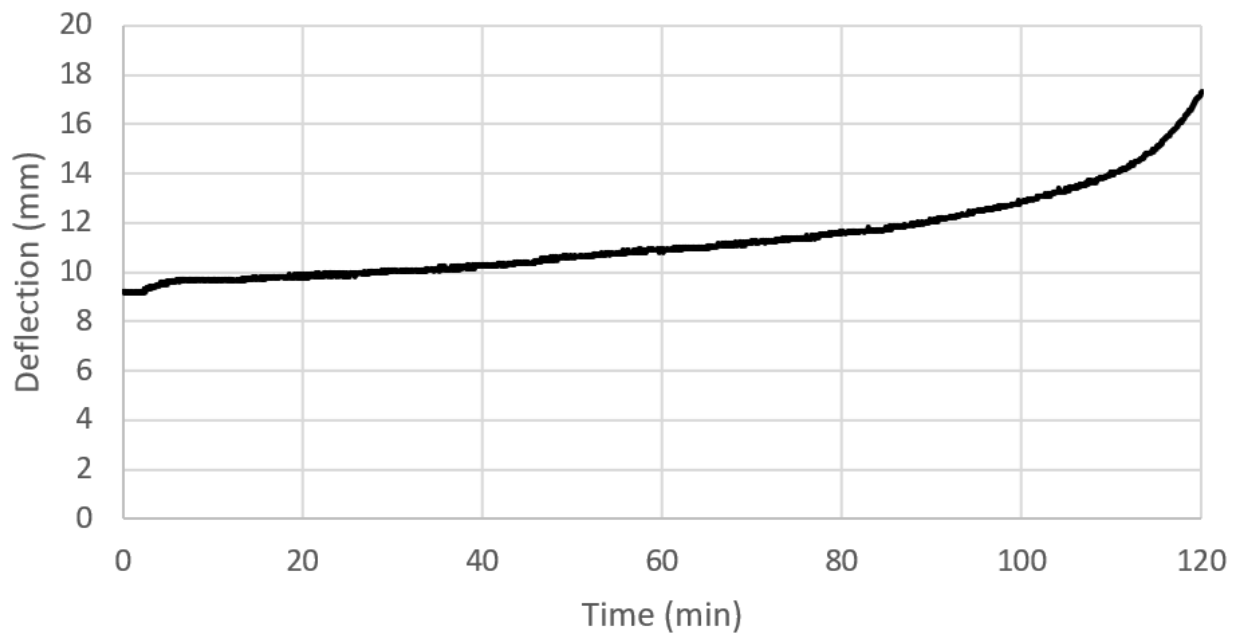
**Figure 36:** Deflection - Test 2

Figure 36 below shows the deflection throughout Test 2. The deflection when the load of 35.8 kips was applied was 9.2 mm. The maximum deflection measured after 2 hours was 17.3 mm (0.682") including the initial deflection. Therefore, deflection during the fire test was 8.1 mm which is 88% of the initial deflection and is considered a relatively small amount of deflection to take place during a fire test.
