Visual Characteristics of Nordic Products

This technical note aims to delineate the requirements for the visual characteristics of Nordic products at the time of manufacturing.

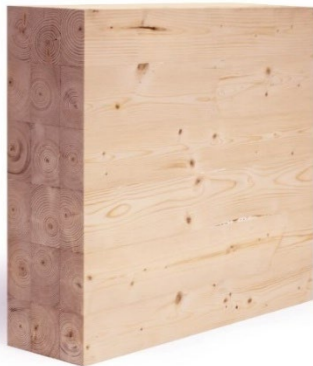
Nordic Lam+ glued-laminated timber (glulam) consists of small wood laminations bonded together in parallel using structural adhesives to form beams and columns.

Sample of Nordic Lam+

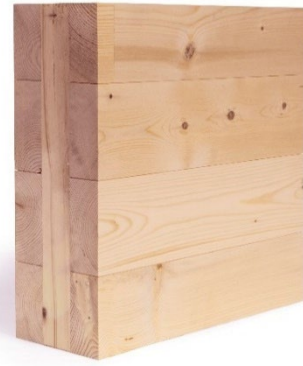
Nordic X-Lam cross-laminated timber (CLT) consists of at least three orthogonal layers of graded sawn lumber that are laminated by gluing with structural adhesives to form large panels.

Sample of Nordic X-Lam

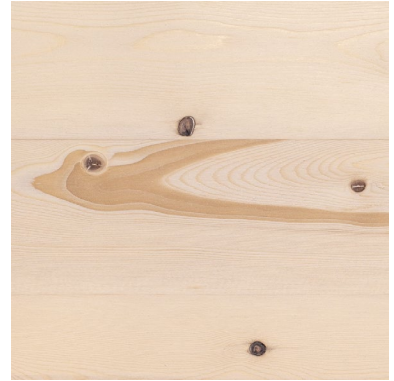
Variation in colour within the same lamella

Variations in colour within the same lamella are marked variations from the natural colour, often appearing as irregularly shaped patches. Neither stained heartwood nor stained sapwood has any impact on mechanical properties. However, they do influence the appearance to different extents.

Requirement(s): No requirements. Variation in colour is an intrinsic characteristic of wood.

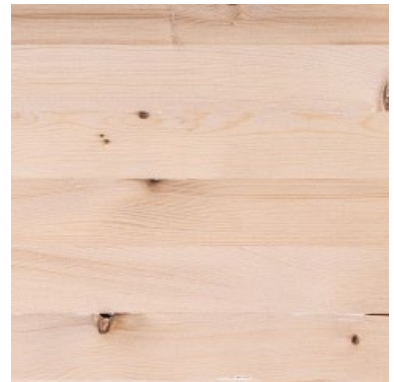
Variation in colour between lamellae

Nordic Lam+ is primarily made of black spruce, whereas Nordic X-Lam is made of spruce, pine, and fir. Variations in color can be observed both between lamellae of different species and within lamellae of the same species.

Requirement(s): No requirements. Variation in colour is an intrinsic characteristic of wood.

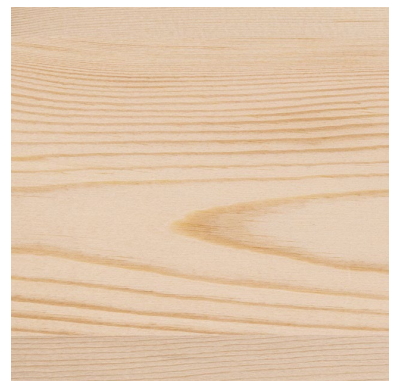
Annual rings are concentric circles on the cross-section of a tree trunk, formed each year by the cambium. They become visible due to the contrasting colours of the latewood and earlywood. Annual rings are visible on the tangential faces of sawn wood, constituting the wood grain.

Requirement(s): No requirements. Wood grain is an intrinsic characteristic of wood.

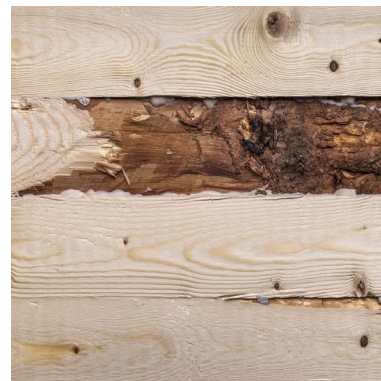
Wane is bark or lack of wood, for whatever cause, at the corner of a square-edged piece. Appearance requirements typically limit the presence of wane in structural lumber. Although the wood is trimmed to remove bark and minimize wane, it is often observed in black spruce lumber.

All occurrences of wane of approximately 9.5 mm (3/8 in.) in width are repaired, regardless of length. Wane up to a maximum length of 203 mm (8 in.) can be repaired using filler. For wane longer than 203 mm (8 in.), wood inserts are used for repairs.

Requirement(s): Unrepaired occurrences of wane must be less than 9.5 mm (3/8 in.).

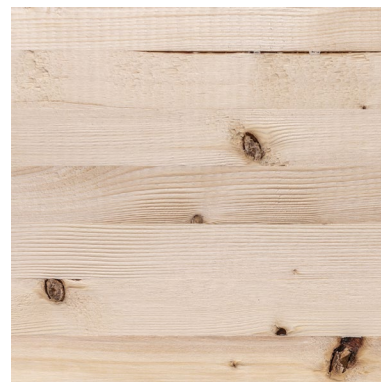
Knot

A knot is the portion of a branch or limb that has been surrounded by subsequent growth of the trunk or other portion of the tree.

Black spruce, the primary species used in Nordic products, is a slow-growing conifer, characterized by its long straight trunk and dense, short branches. These branches result in numerous small knots, commonly seen in Nordic products.

Requirement(s): No requirements. Sound knots are not a structural concern.

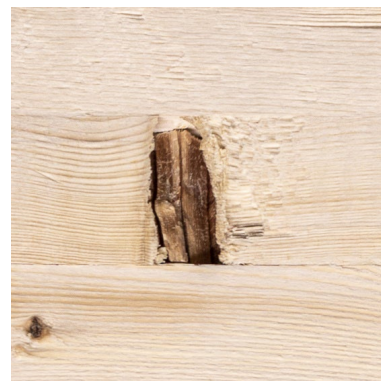
Knot hole

Knot holes form when a knot loosens from the surrounding wood. These holes may extend either partially or completely through the element. Holes that only partially penetrate the element are also known as surface holes.

In exposed surfaces, holes longer than 38 mm (1-1/2 in.) are repaired. Individual holes may exceed 38 mm (1-1/2 in.) in length if their area does not exceed 6.45 cm² (1 in.²).

Requirement(s): In exposed surfaces, unrepaired holes must be less than 38 mm (1-1/2 in.) in length or have an area less than 6.45 cm² (1 in.²).

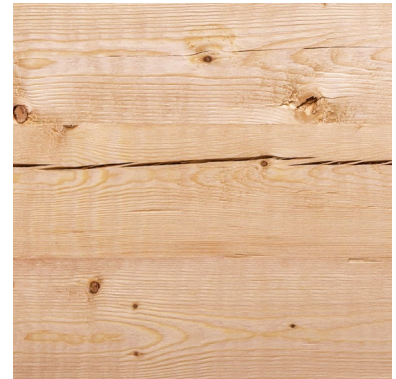
Check

Checking is a naturally occurring consequence of the seasoning process of wood. The outer fibres lose moisture to the surrounding atmosphere and attempt to shrink, but the inner portion of the timber member loses moisture at a much slower rate. The different rates of shrinkage can cause the wood to check or split. The checking (and shrinkage) process will stabilize as the moisture content of the member reaches equilibrium with the surrounding environmental conditions.

Checks near bond lines should not be confused with delamination. Checks are openings that occur parallel to the natural grain of the laminations. They show the separated wood fibre on each exposed surface at the check openings. Delamination is the separation of layers in a laminate due to the failure of the adhesive, either in the adhesive itself or at the interface between the adhesive and the adherend. With delamination, the surfaces of the laminations at the opening are smooth. Delamination is highly unlikely in mass timber products.

- Members in compression (e.g., column or post) – Partial checking is not a structural concern. The only time a check becomes a structural concern is if it develops into a full-length (the entire height of the column or post, on both sides of the member). In this very unusual case, the structural capacity of the member should be confirmed by a qualified design professional.

- Members in bending
 - o End checks (end splits) – End checks with a length less than half the depth of the member pose no structural concern. For other cases, consult a qualified design professional.

- o Side checks – Side checks that are no greater than one-third the width and one-third the length of the member have a negligible effect on the structural performance of the member. Side checks can appear at any depth of the member. For other cases, consult a qualified design professional.

- o Bottom checks – Bottom checks parallel to the natural grain of the lumber are not considered to be of structural significance, even if they are the full depth of the face lamination. For other cases, consult a qualified design professional.

Requirement(s): A non-lamination, less than 300 mm (12 in.) in length and limited to one per bond line, can be considered as a check (refer to Natural Visual Characteristics – Checks). For other cases, contact Nordic Structures.

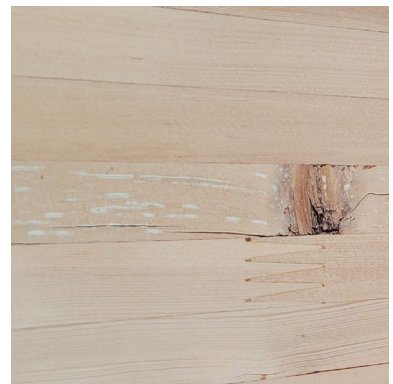
White specks are caused by a fungus and generally have a negligible effect on the structural performance of the member. This fungus is not harmful and no longer grows when the wood is dry.

Requirement(s): White specks must remain occasional. In dry-service conditions, white specks are not a structural concern.

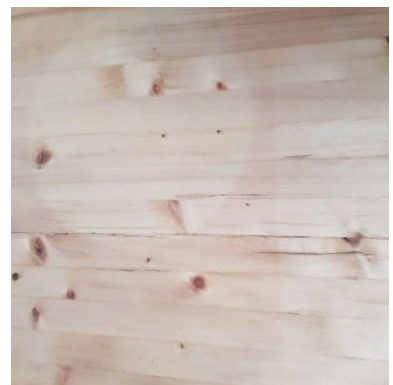
Discolouration can result from wood exposure to ultraviolet (UV) rays. The type and intensity of discolouration vary depending on the level of exposure.

To minimize discolouration, Nordic products are packaged for protection during transport. Additionally, a clear and penetrating protective undercoat is applied at the factory, unless otherwise noted. For more information on finishing Nordic products, refer to technical note [NS-NT205](#).

Requirement(s): No requirements. Discolouration is not a structural concern.

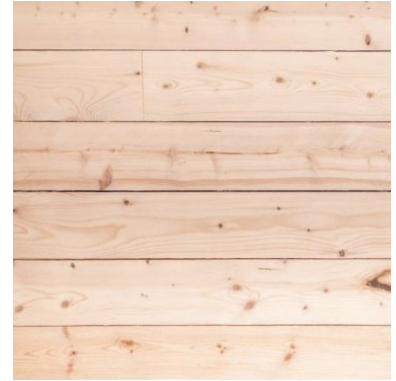
Gap between adjacent lamination edges – Face layers

Laminations of Nordic X-Lam cross-laminated timber (CLT) are not edge glued. At the time of manufacturing, laminations in the face layers are tightly fit, and the gaps between adjacent laminations edges are minimal. However, these gaps can become more noticeable when the product is exposed to a dry environment.

Requirement(s): Edge joint gaps in face layers shall not exceed 6.4 mm (1/4 in.).

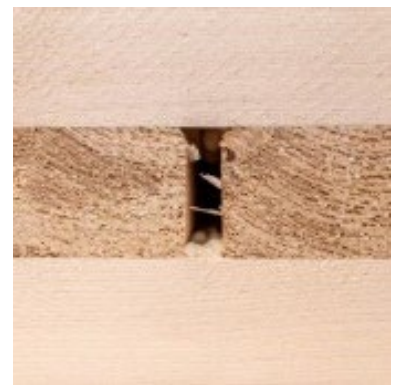
Gap between adjacent lamination edges – Other layers

Laminations of Nordic X-Lam cross-laminated timber (CLT) are not edge glued. Gaps between adjacent lamination edges in layers other than the face layers are usually more pronounced and visible along the panel edges. It's important to note that the panel edges are not intended to be exposed.

Requirement(s): Edge joint gaps in layers other than the face layers shall not exceed 9.5 mm (3/8 in.).

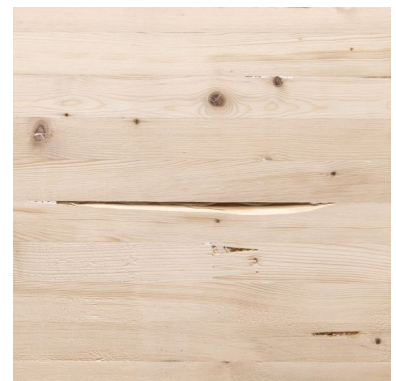
Miss

Misses are cavities in laminations that occur when a section of wood or a dry resin pocket detaches during the planing process.

In exposed surfaces, misses longer than 38 mm (1-1/2 in.) are repaired. Individual misses may exceed 38 mm (1-1/2 in.) in length if their area does not exceed 6.45 cm² (1 in.²).

Requirement(s): In exposed surfaces, unrepaired misses must be less than 38 mm (1-1/2 in.) in length or have an area less than 6.45 cm² (1 in.²).

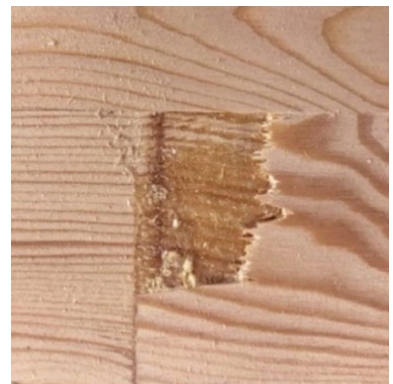
Torn joint

Torn joints are sections of finger joints that are torn off during the jointing, planing, or sanding process.

In exposed surfaces, torn joint longer than 38 mm (1-1/2 in.) are repaired. Individual torn joints may exceed 38 mm (1-1/2 in.) in length if their area does not exceed 6.45 cm² (1 in.²).

Requirement(s): In exposed surfaces, unrepaired torn joints must be less than 38 mm (1-1/2 in.) in length or have an area less than 6.45 cm² (1 in.²).

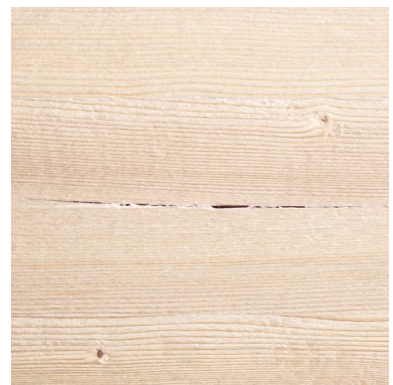
Non-lamination

Non-laminations are planing irregularities that prevent laminations from fully bonding together.

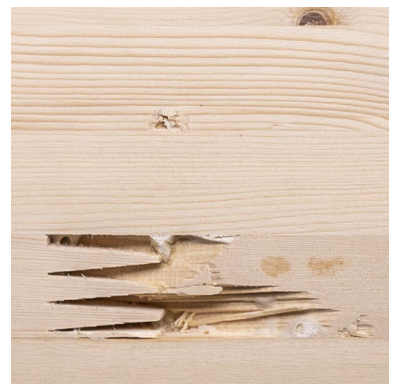
Void in finger joint

Voids in finger joints are caused by crushing during the jointing process.

In exposed surfaces, voids longer than 38 mm (1-1/2 in.) are repaired. Individual voids may exceed 38 mm (1-1/2 in.) in length if their area does not exceed 6.45 cm² (1 in.²).

Requirement(s): In exposed surfaces, unrepaired holes in finger joint must be less than 38 mm (1-1/2 in.) in length or have an area less than 6.45 cm² (1 in.²).

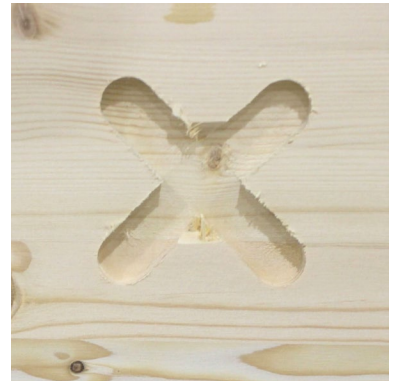
Non-visible face mark

The non-visible faces of glued-laminated timber elements are marked with an X at the factory. These faces have an industrial appearance grade; thus, the previously mentioned criteria do not apply.

Requirement(s): X markings must be applied at the factory and be located on surfaces not exposed to view at final completion.
